PNC Field Stadium Study Released

EXECUTIVE SUMMARY

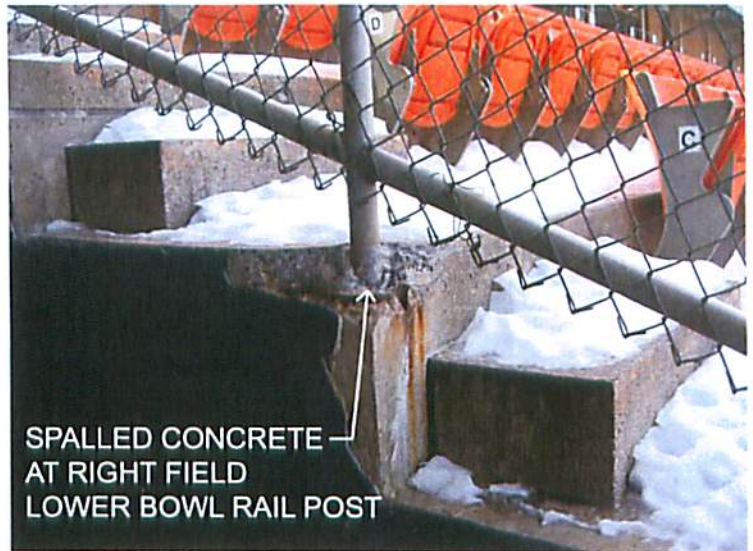
Photo S-6

- 1) **Spalled Concrete:** Structural remediation is required at locations where concrete has cracked and spalled at guardrail post locations and at cast-in-place concrete treads on precast tiers (see Photo S-5 to S-8). These conditions occur at various locations throughout the lower and upper seating bowls. The cracked and spalled concrete present safety and liability concerns due to potential of falling loose concrete, potential tripping hazards and compromised integrity of the rail anchorage.

SPALLED CONCRETE
AT RIGHT FIELD
LOWER BOWL RAIL POST

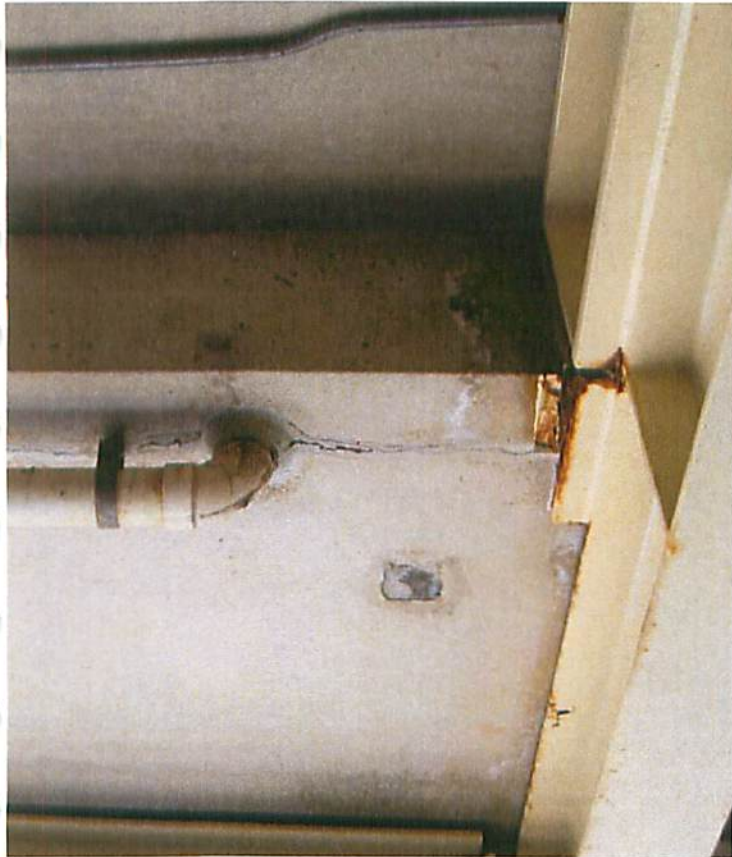
Photo S-22

- 5) **Cracking Precast Concrete:** Cracking is evident where the back of the precast tub meets the risers at the Suite Level behind the first base dugout (see Photo S-22). The crack is visible from the underside of the unit and runs longitudinally along the precast member and appears to be related to the location of a drainage pipe at the back of the precast section. Further investigation of this crack is required to see if the crack extends through the thickness of the tub and is evident from the top side. This crack should be repaired with a structural repair adhesive. The width of the crack will need to be evaluated to determine if a gravity fed adhesive or an injection adhesive is appropriate. This condition was evident in several locations; therefore, a thorough review of the bowl should be conducted to confirm that this condition does not occur in other locations.

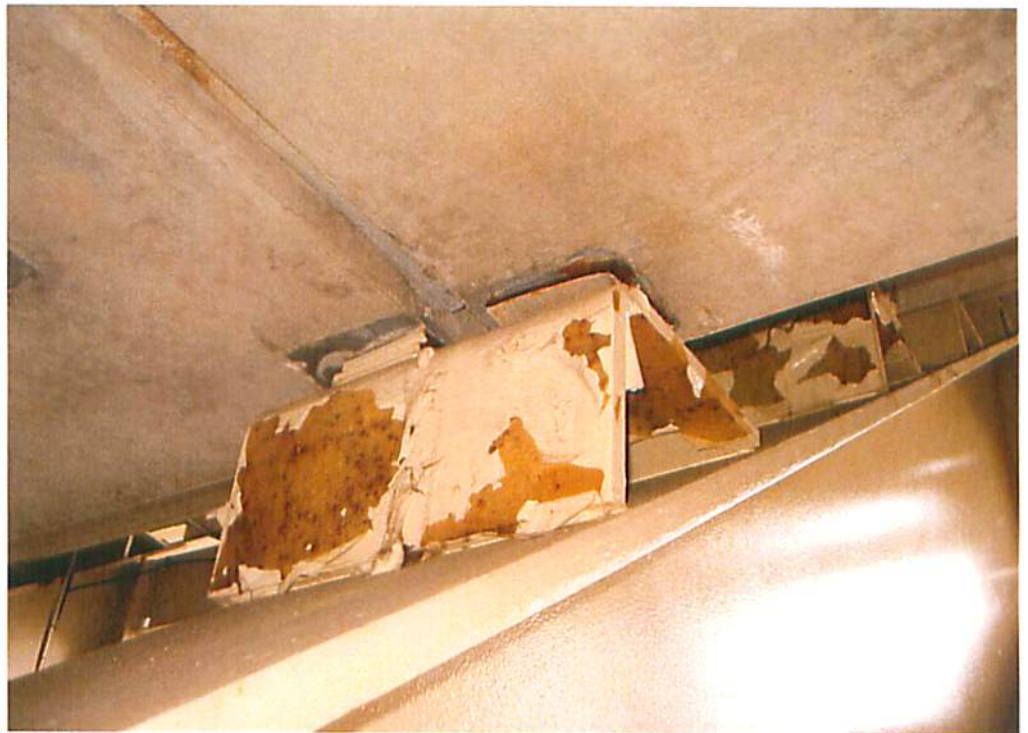
Photo S-25

- 4) **Peeling Paint:** The existing building structural frame exhibits some minor localized coating failure characterized by peeling paint on the column bases, beams, rakers and precast seats and some light rust at the column bases, particularly at the open air concourses (See Photo S-25). The coating system needs to be recoated to alleviate rusting and corrosion to the structure commensurate with the other identified work at the facility relative to the moisture issues.

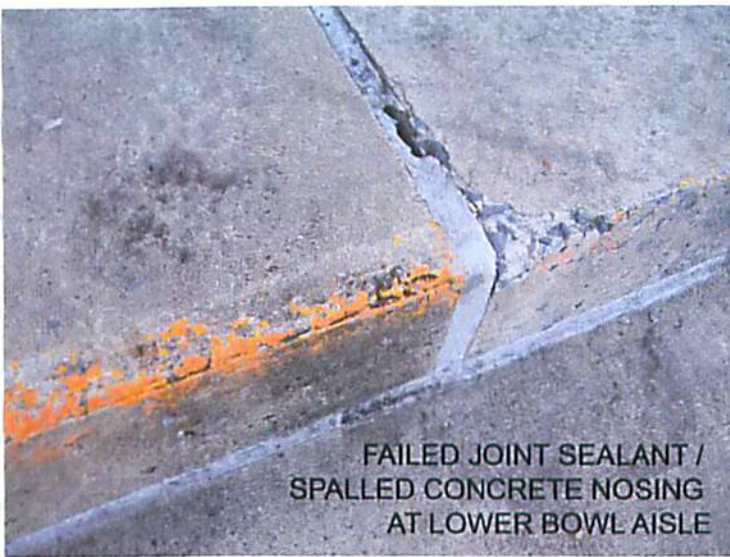
- 1) **Sealant Joints:** The sealant joints between the precast tiers in the seating bowl are in need of replacement. The sealant material has exceeded its service life and is now failing (See Photos A4 - A7). There is evidence of water infiltration occurring at every level throughout the seating bowl. The failed sealant joints are the primary cause of water damage below the seating tiers, in some cases significant, such as above the suites and press areas. Depending on the severity of the annual weather exposure and the type and frequency of the seating bowl cleaning practices (i.e. power washing), sealant materials typically have a service life of 5-7 years. We recommend replacement of all sealant in the joints in the entire seating bowl with either a urethane or silicone product.

FAILED JOINT SEALANT /
SPALLED CONCRETE NOSING
AT LOWER BOWL AISLE

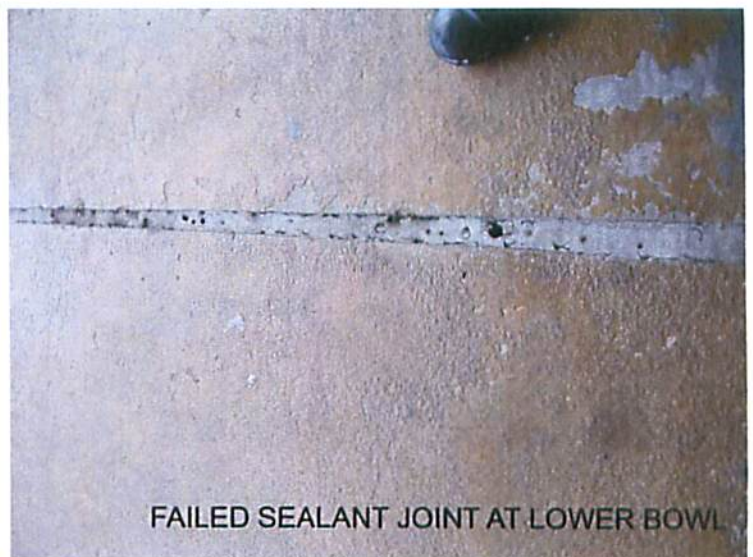
A5

FAILED SEALANT JOINT AT LOWER BOWL

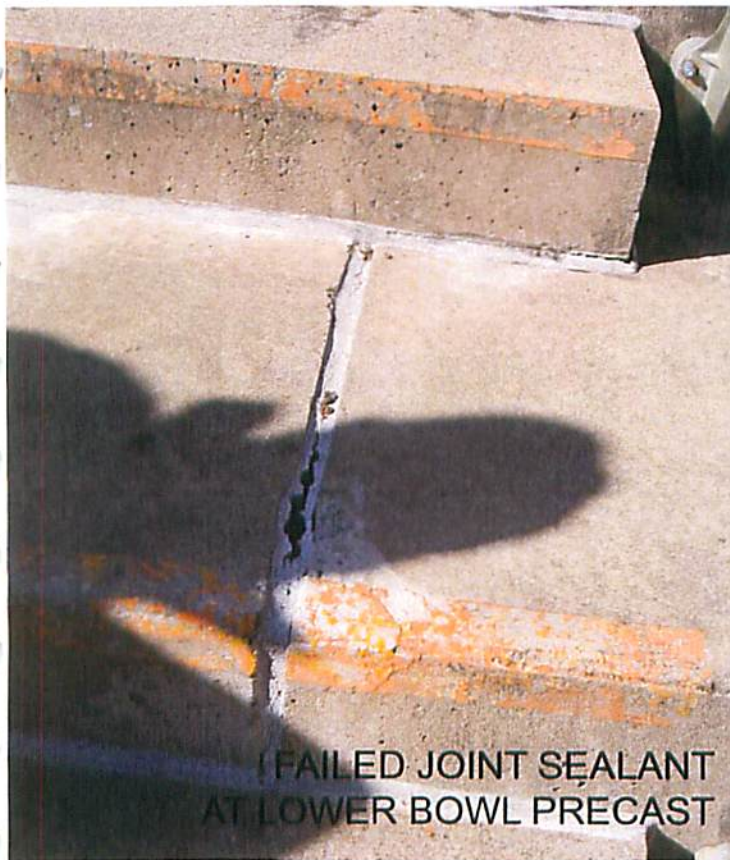
A6

FAILED JOINT SEALANT
AT LOWER BOWL PRECAST

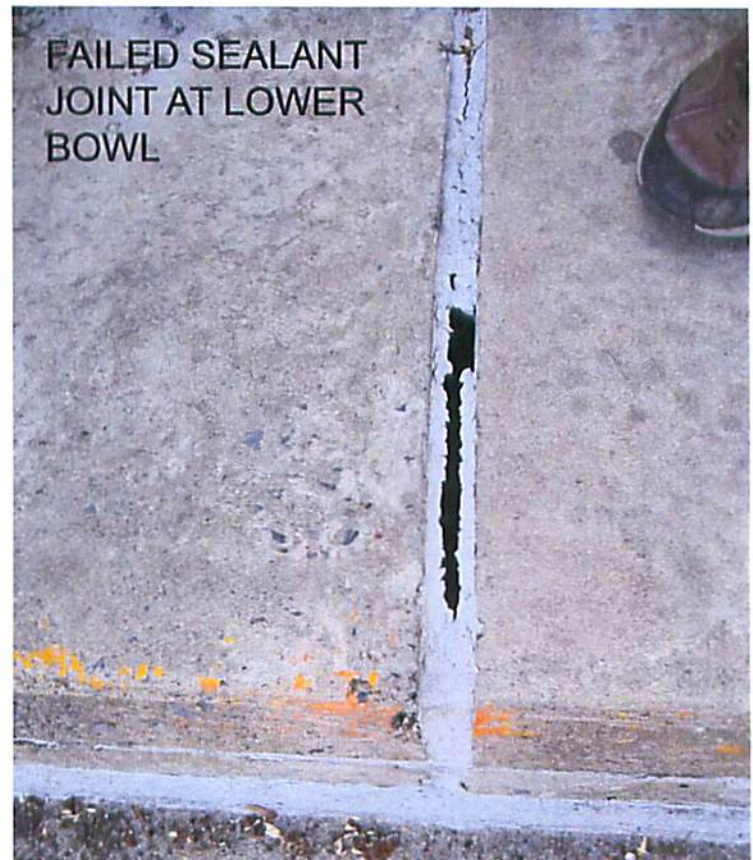
A7

FAILED SEALANT
JOINT AT LOWER
BOWL

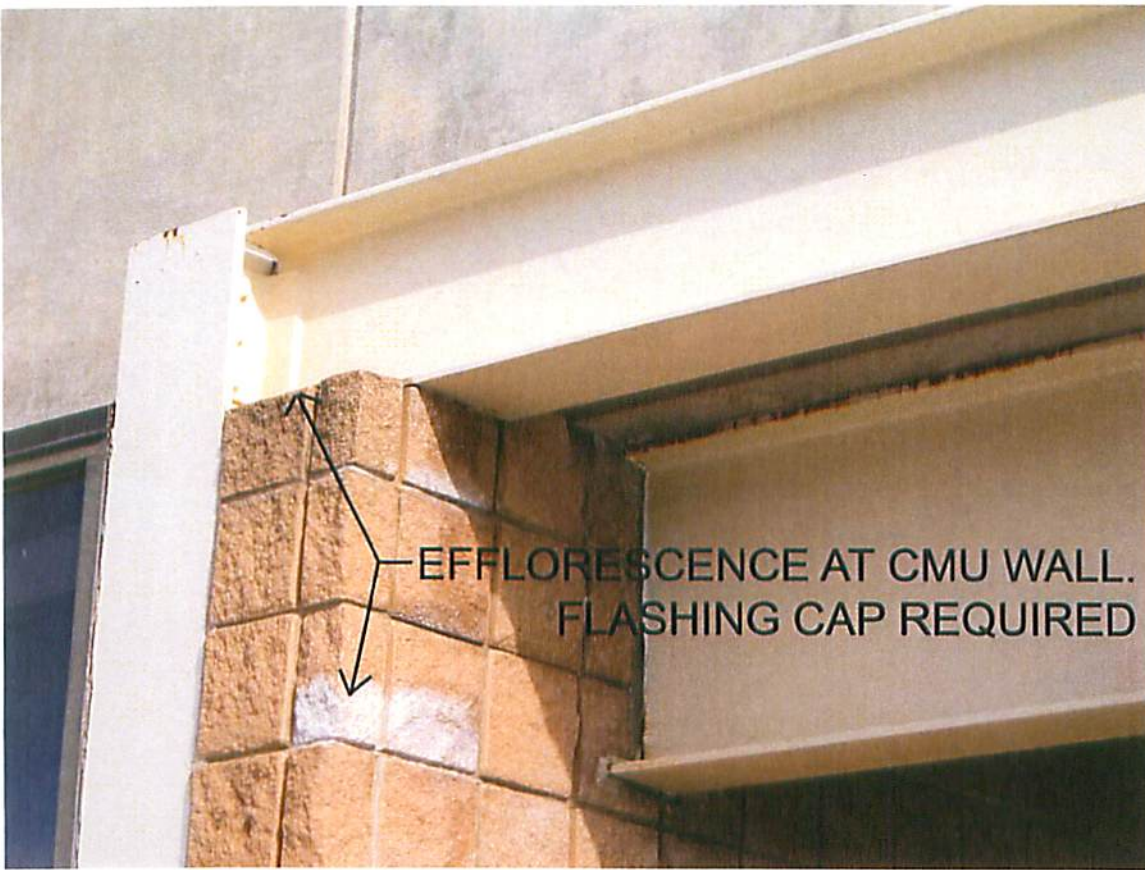
4) **Exterior CMU Walls:** In some locations, the exterior CMU walls have been observed to have efflorescence, which is characterized by a white chalky residue from the salts leaching out of the mortar. In a few locations the mortar joints are beginning to fail, with cracked and loose mortar being observed. Both conditions are a result water infiltration into the wall, which is not designed with a cavity to allow the moisture to escape. In one particular location, near the elevator adjacent to the main entrance, several masonry units appear to be loose due to near complete deterioration of the mortar joints (See Photos A11 - A12). This particular condition seems to be caused by the lack of cap flashing at the top of the wall and/or lack of control joints near the corner of the wall. We recommend the immediate remediation of the loose masonry units due to the potential life safety hazard this condition presents. The failed mortar joints should be repointed once a metal cap flashing is installed at the top of the wall. In the near-term, we recommend all areas of masonry efflorescence be cleaned and a clear silane/siloxane type topical sealer be applied to help prevent future water infiltration into the single wythe walls.

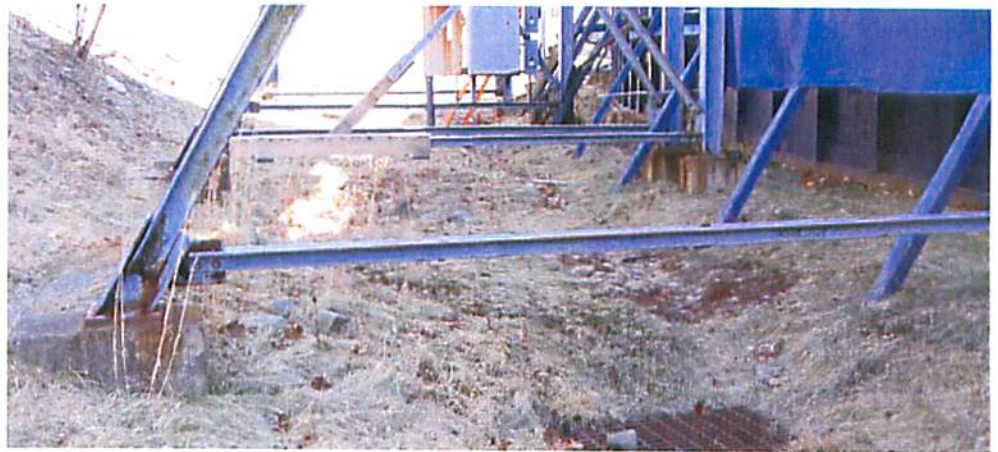
A27

- 5) **Regrading Outfield Area:** The grading and drainage around the perimeter of the outfield wall appears to be inadequate. (See Photo A27). There are only 2-3 catch basins observed in an area approximately 700 feet long. This seems inadequate given the steep terrain beyond the outfield wall. There are signs of ponding water and soil erosion. In the long-term, the area behind the outfield fence should be evaluated. The area could be re-grading and additional catch basins added to better channel the runoff and curtail further erosion. Vegetation and/or reseeding the steep grades should also be considered to further stabilize the slopes.

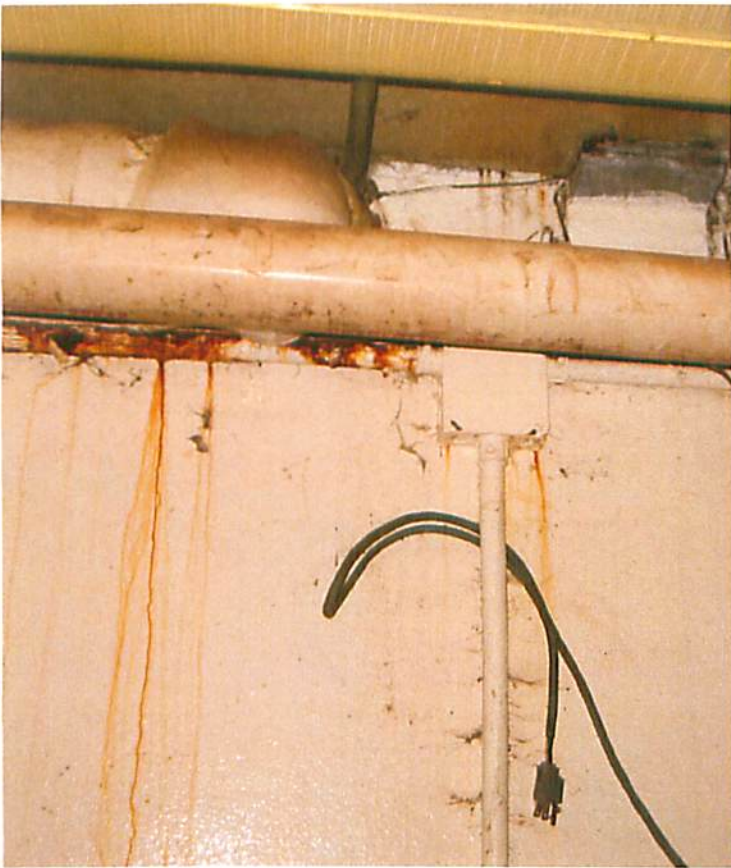
- 2) **Conduit:** In many locations along concourses, on the suite level and in the dug-out areas the conduits were observed to be in poor condition and rusting (See Photos E4 - E6). In some cases the conduit has deteriorated to the point of exposing the insulated electrical conductors (See Photo E7). Primarily, this is due to excessive exposure to moisture and water caused by the failure of caulk joints in the concourse slabs and seating bowl. In fact,

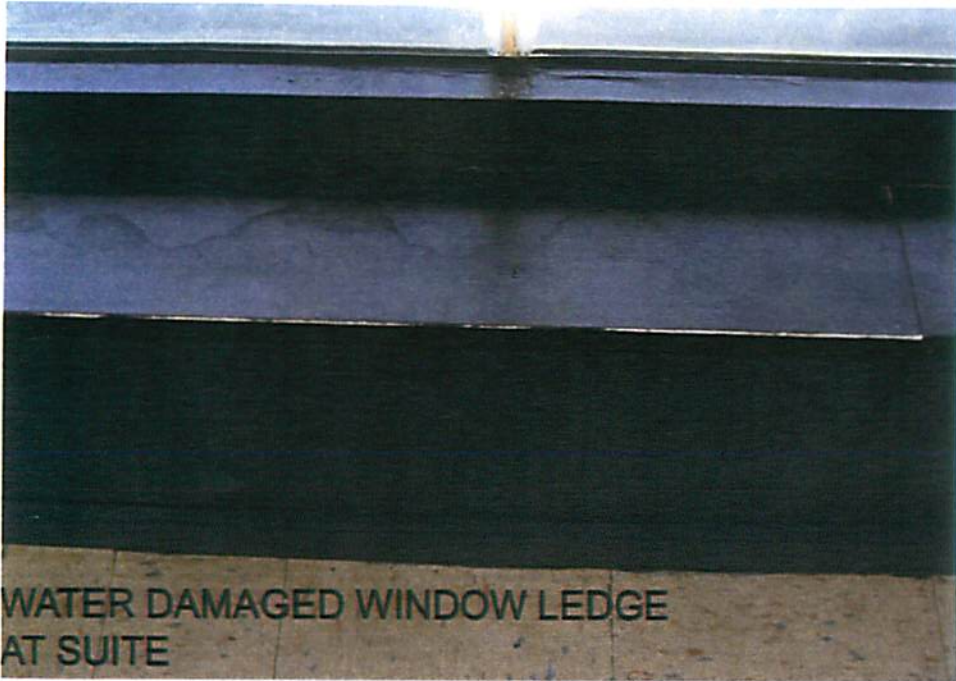
WATER DAMAGED WINDOW LEDGE
AT SUITE

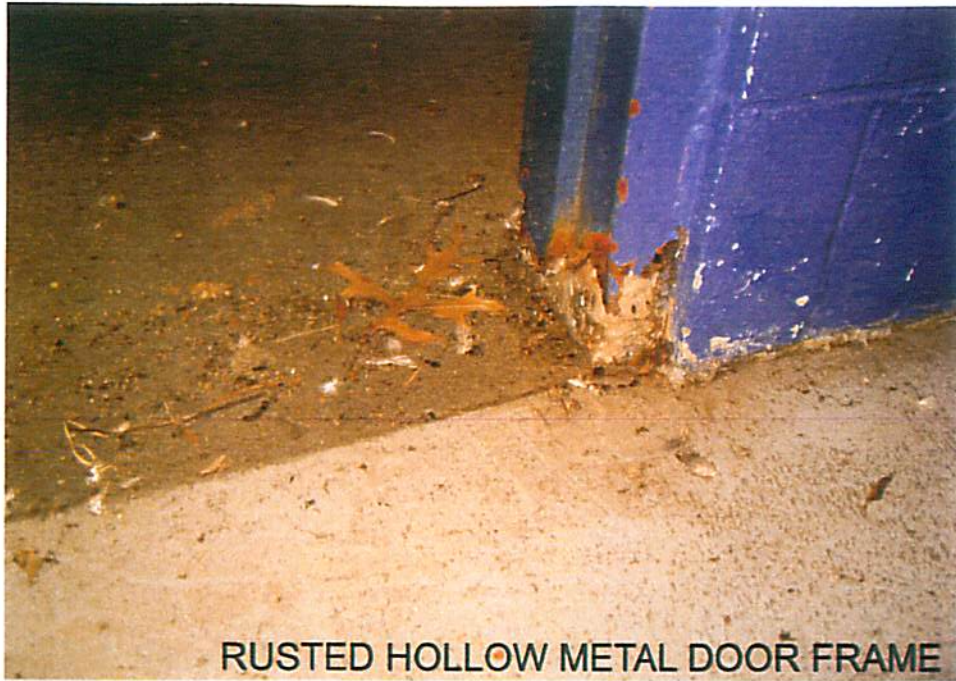
RUSTED HOLLOW METAL DOOR FRAME

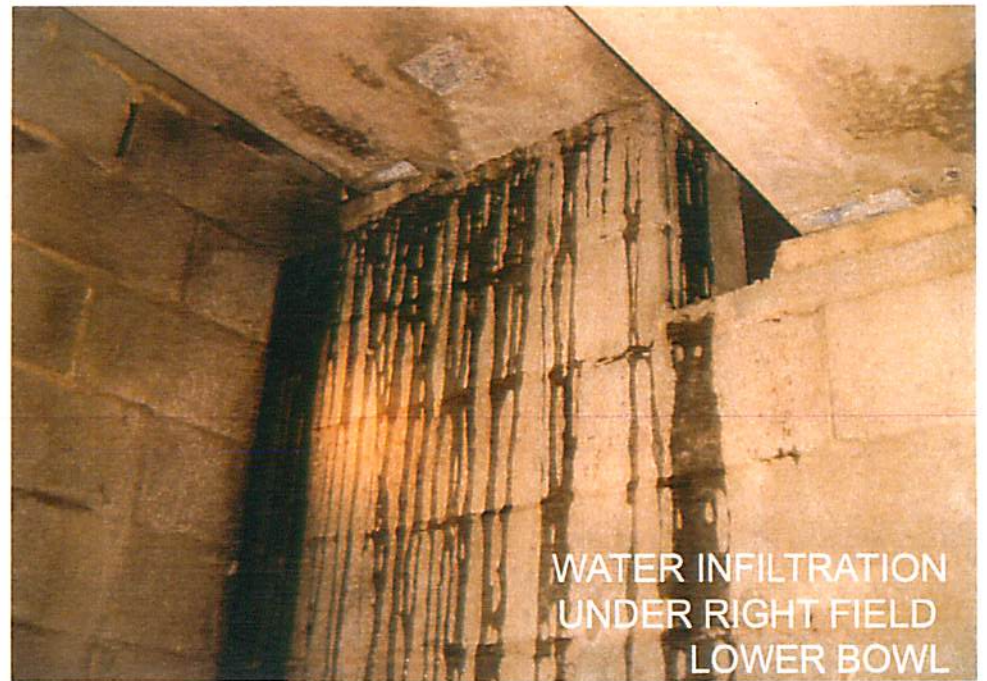
WATER INFILTRATION
UNDER RIGHT FIELD
LOWER BOWL

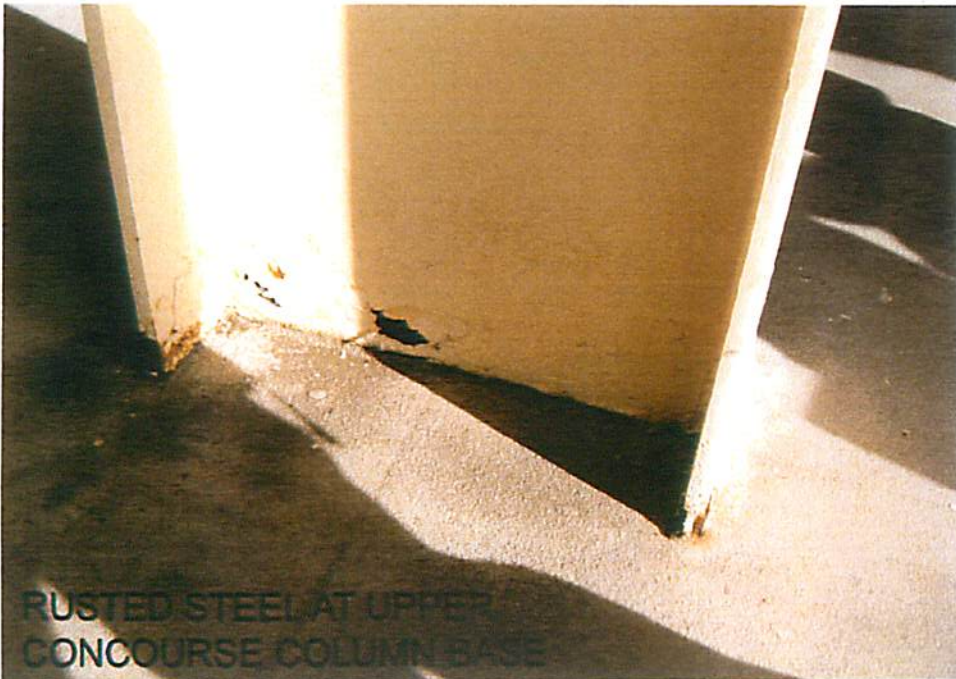
RUSTED STEEL AT UPPER
CONCOURSE COLUMN BASE

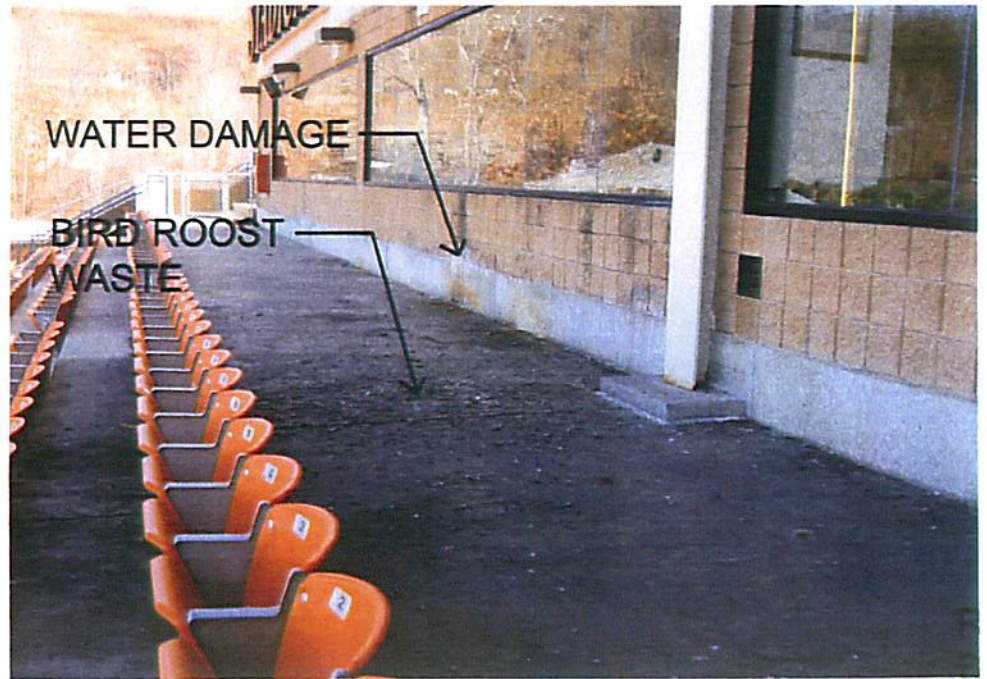
WATER DAMAGE
BIRD ROOST
WASTE

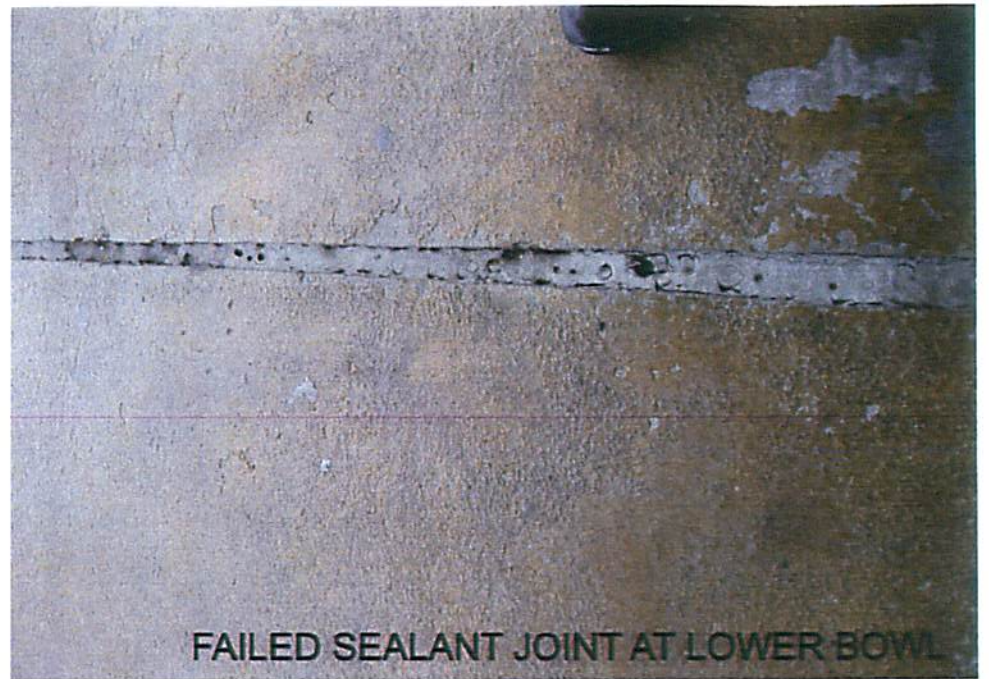
FAILED SEALANT JOINT AT LOWER BOWL

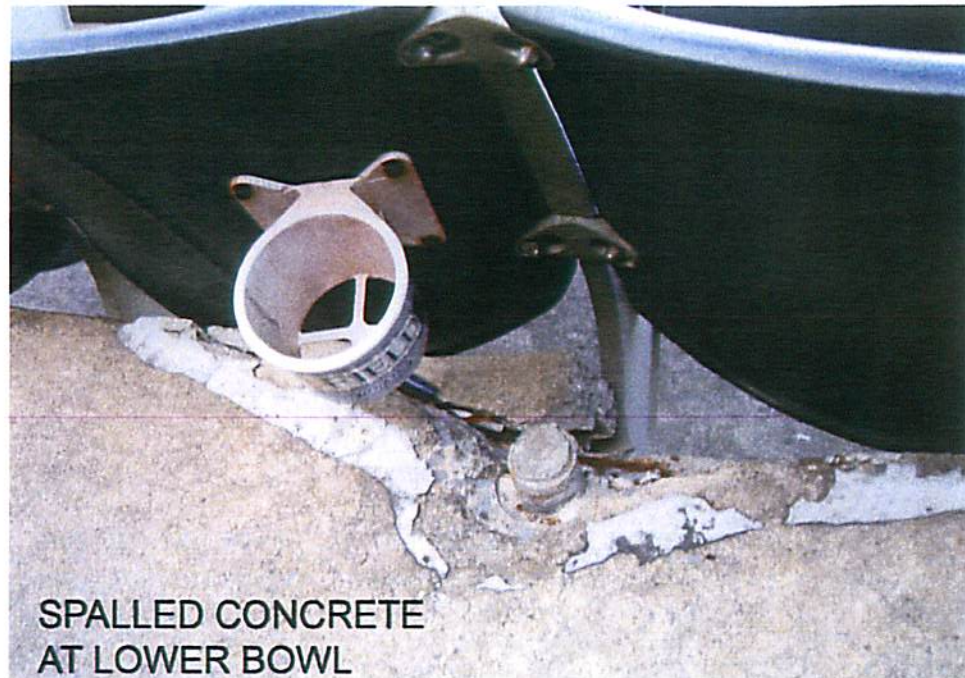
SPALLED CONCRETE
AT LOWER BOWL

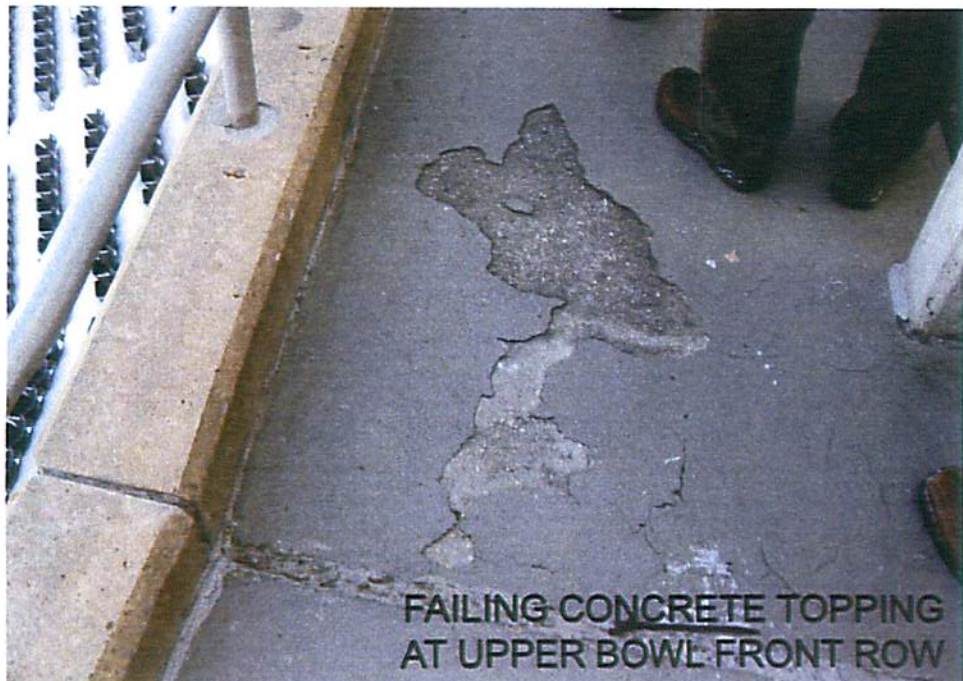
FAILING CONCRETE TOPPING
AT UPPER BOWL FRONT ROW

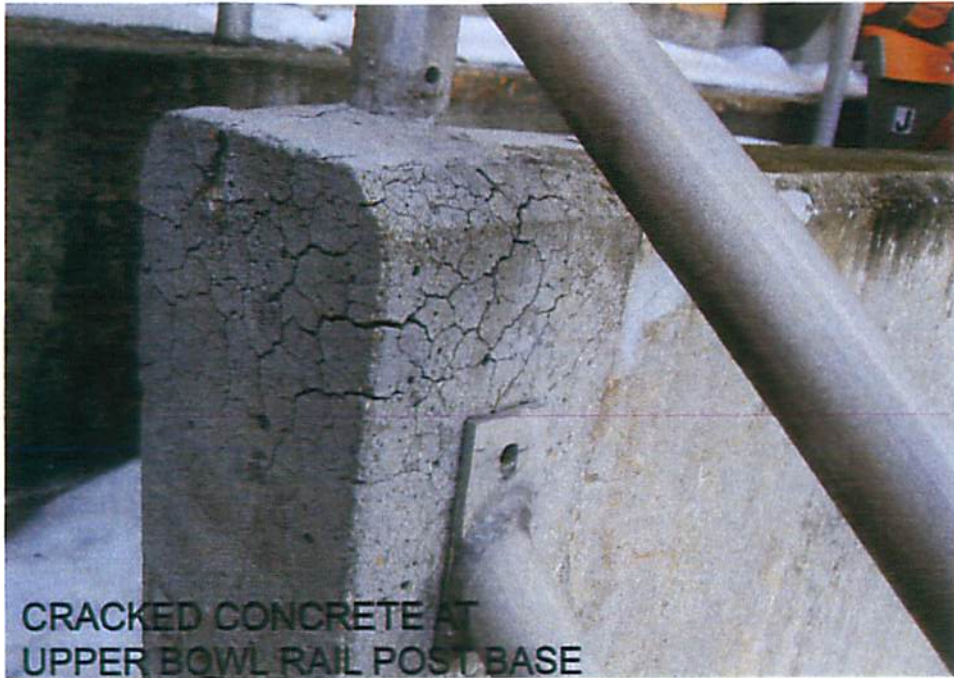
CRACKED CONCRETE AT
UPPER BOWL RAIL POST BASE

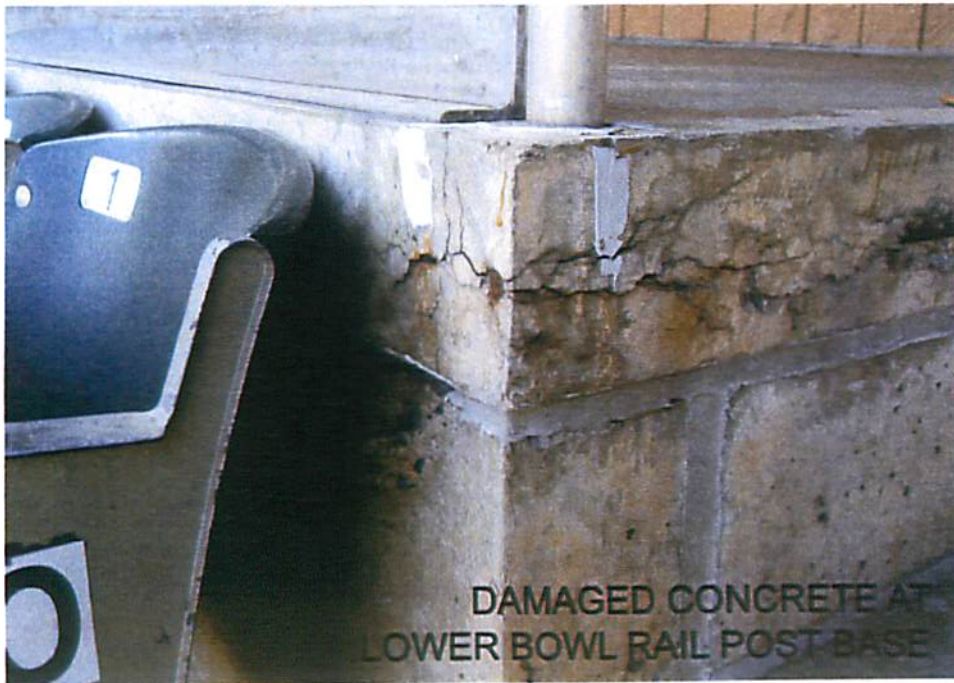
DAMAGED CONCRETE AT
LOWER BOWL RAIL POST BASE

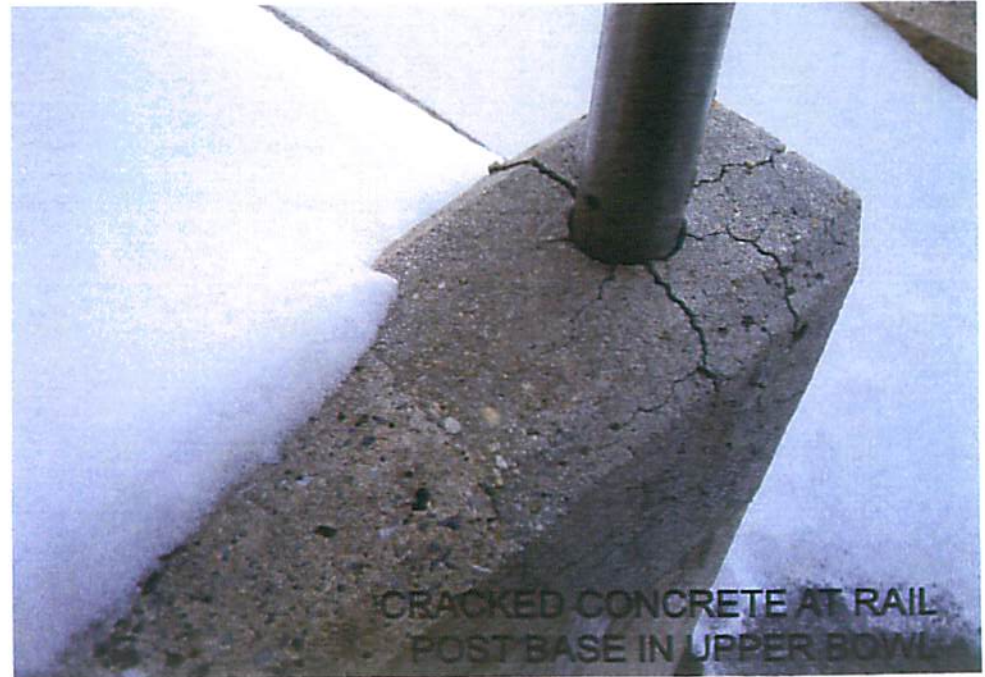
CRACKED CONCRETE AT RAIL
POST BASE IN UPPER BOWL

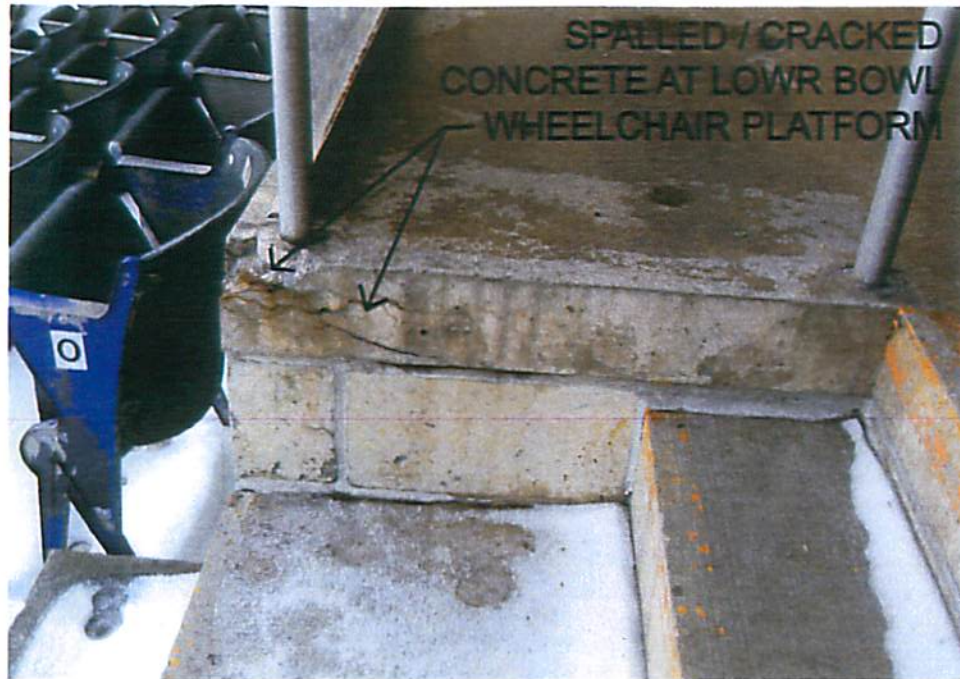
SPALLED / CRACKED
CONCRETE AT LOWR BOWL
WHEELCHAIR PLATFORM

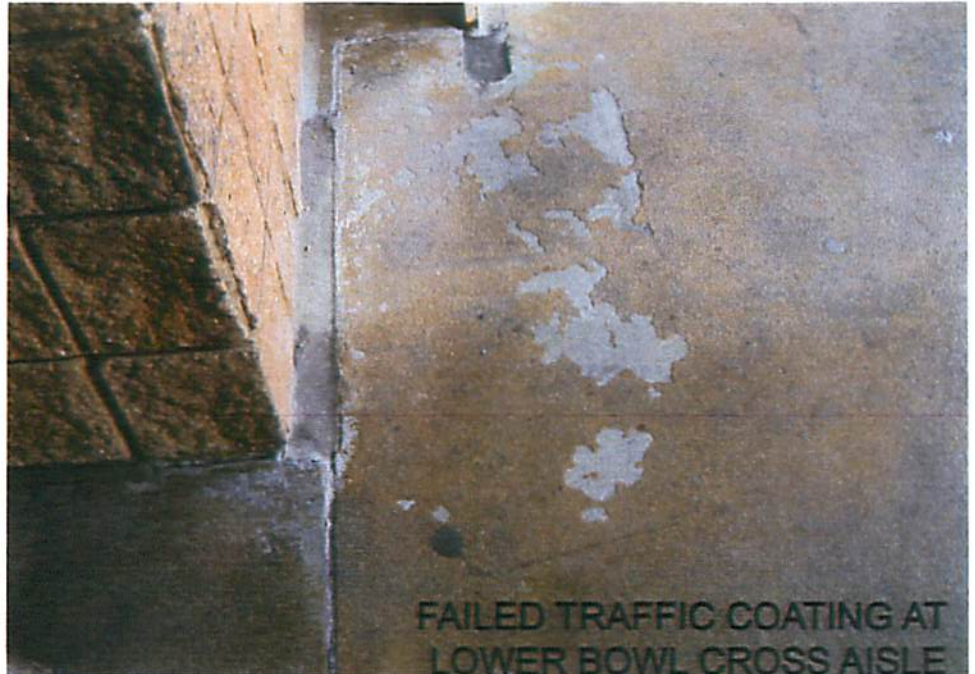
FAILED TRAFFIC COATING AT LOWER BOWL CROSS AISLE

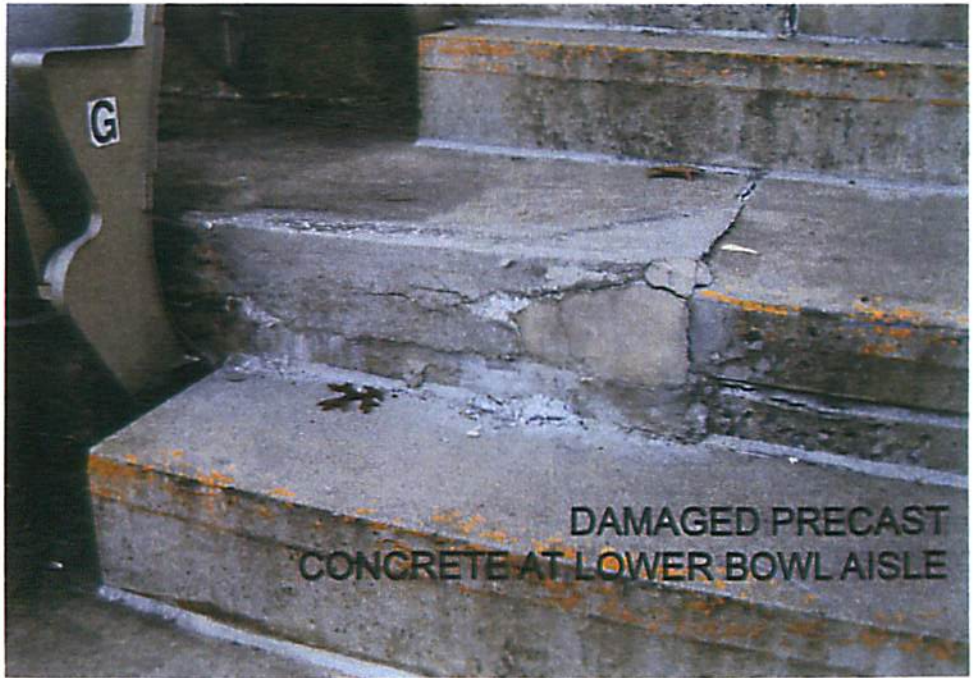
DAMAGED PRECAST CONCRETE AT LOWER BOWL AISLE

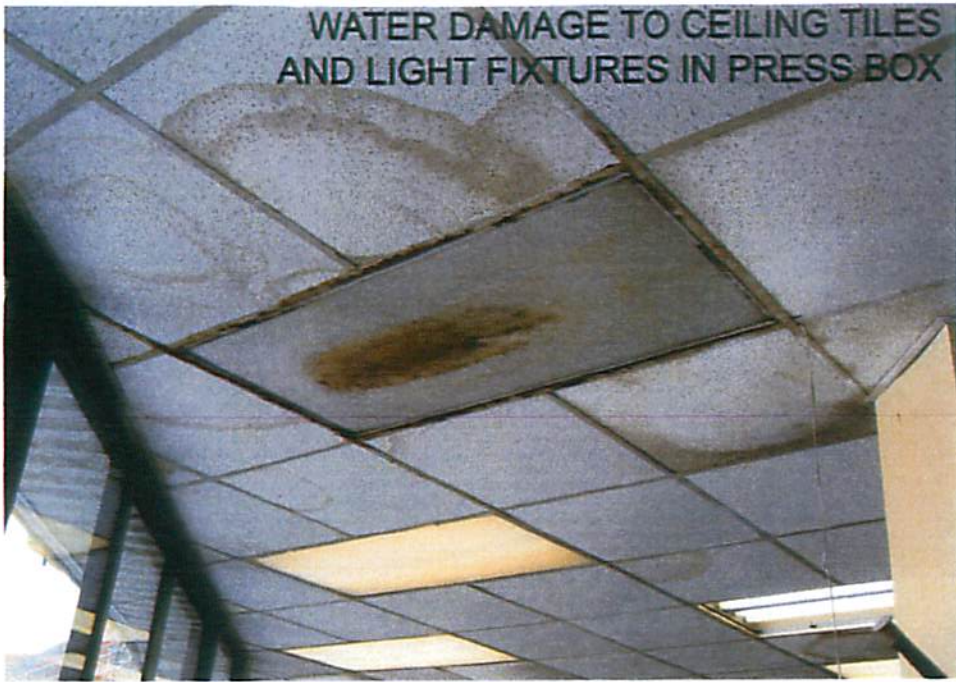
WATER DAMAGE TO CEILING TILES AND LIGHT FIXTURES IN PRESS BOX

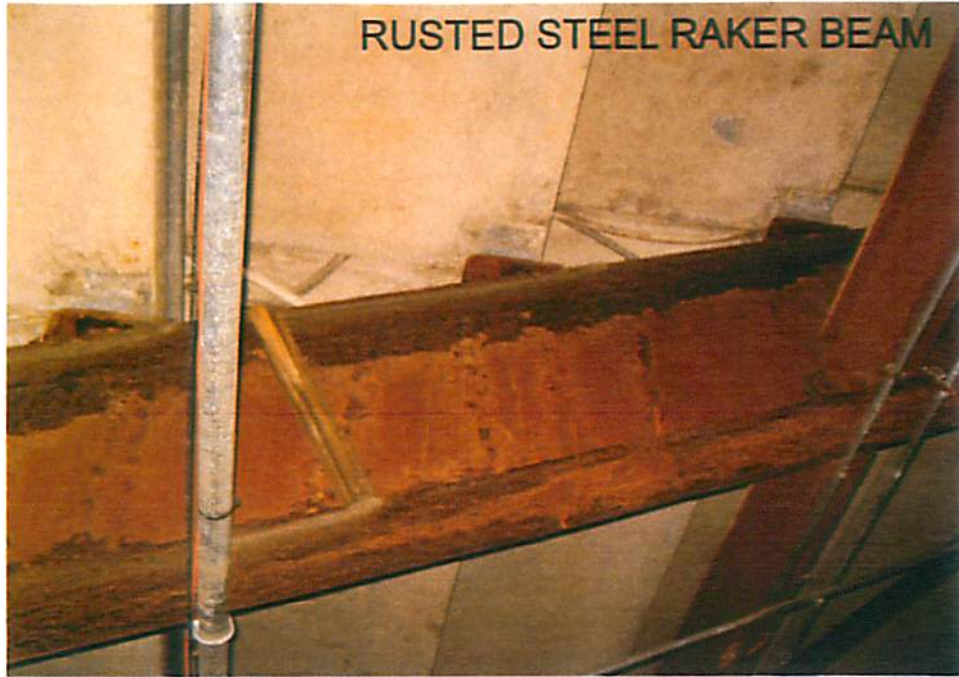
RUSTED STEEL RAKER BEAM

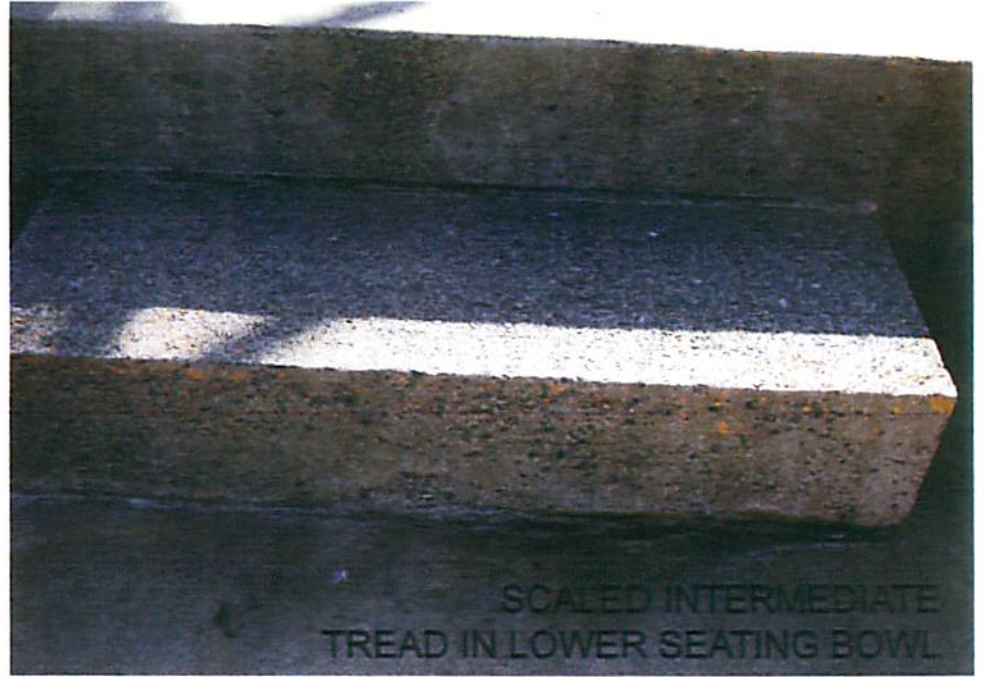
SCALED INTERMEDIATE
TREAD IN LOWER SEATING BOWL

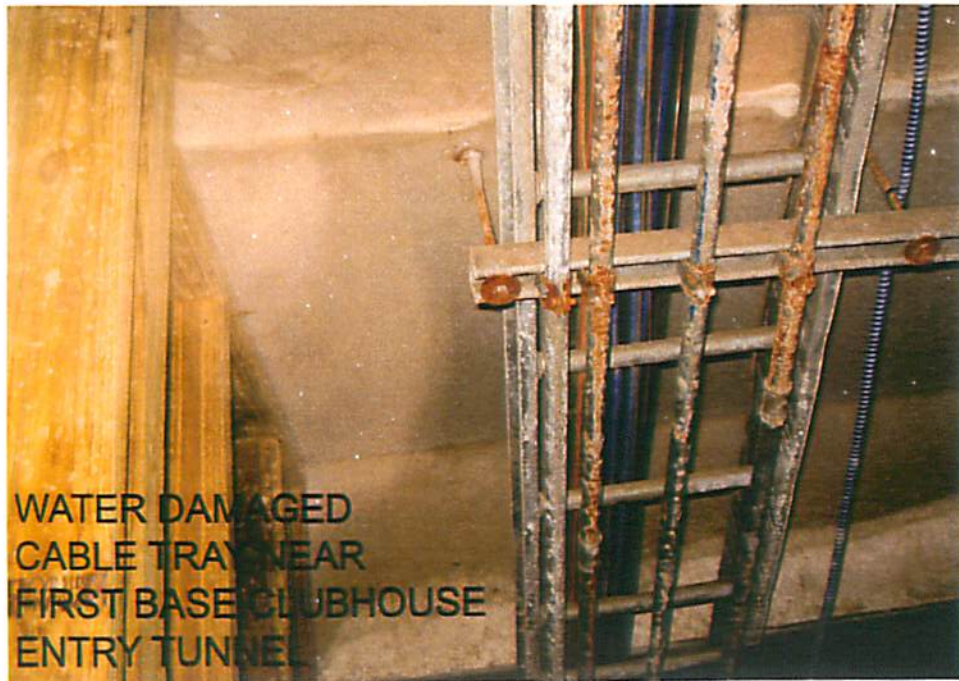
WATER DAMAGED
CABLE TRAY NEAR
FIRST BASE CLUBHOUSE
ENTRY TUNNEL

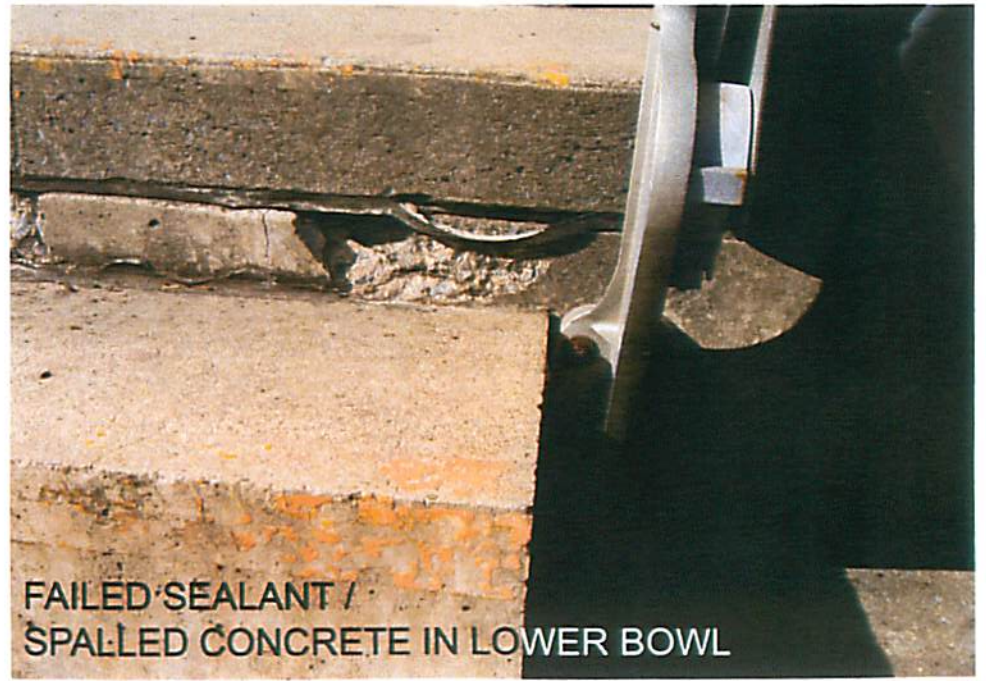
FAILED SEALANT /
SPALLED CONCRETE IN LOWER BOWL

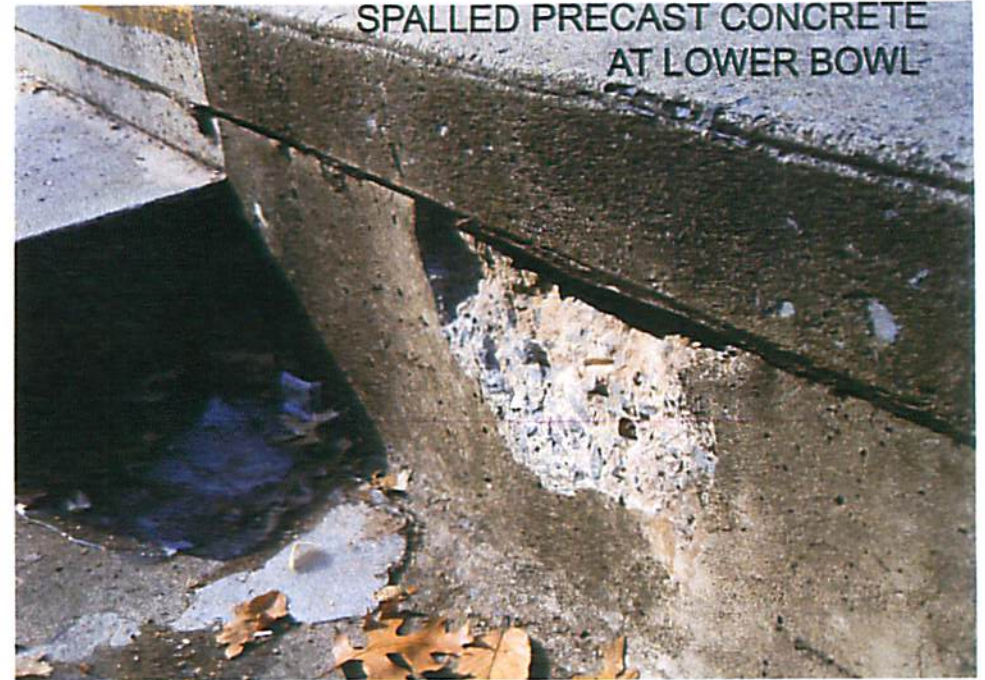
SPALLED PRECAST CONCRETE
AT LOWER BOWL

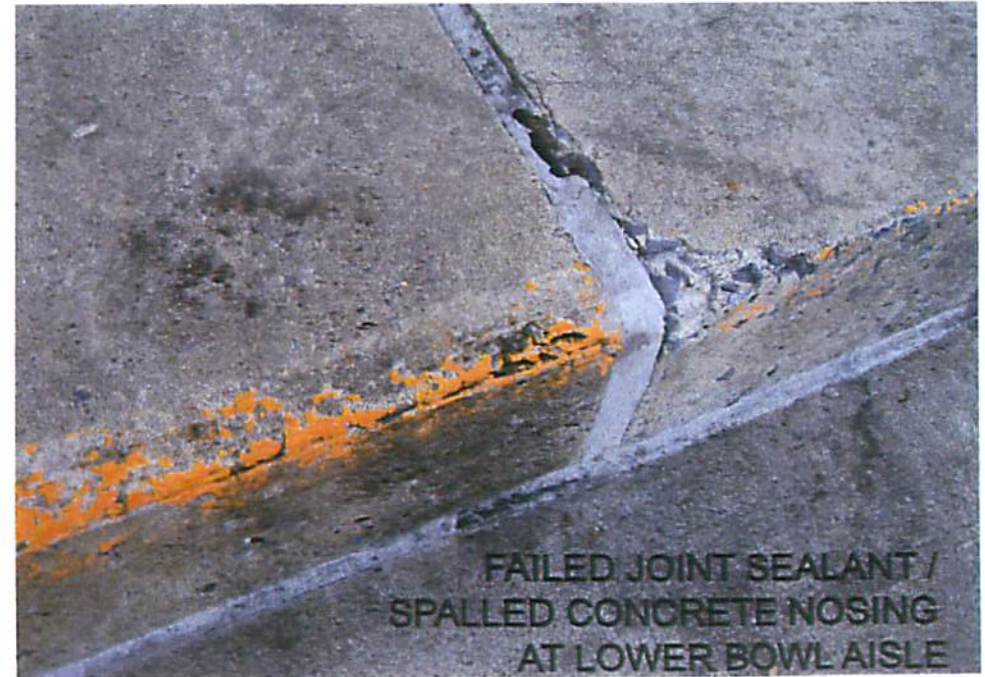
FAILED JOINT SEALANT /
SPALLED CONCRETE NOSING
AT LOWER BOWL AISLE
