PNC Field Stadium Study Released

EXECUTIVE SUMMARY

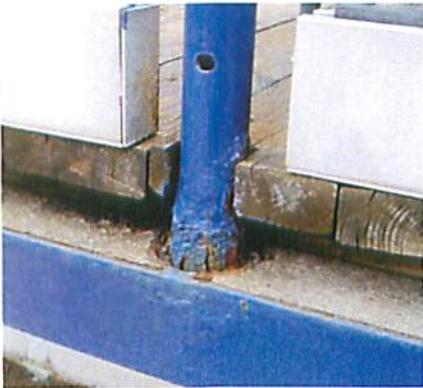
Photo S-1

- 1) The right field party deck is a wood deck surface built over a concrete slab on metal deck structure supported by steel bar joists. The perimeter of the concrete slab on metal deck edge is formed by an exposed bent steel plate. Perimeter painted steel guardrail posts are set in sleeves within the slab on metal deck directly against the perimeter bent plate. The bases of the perimeter rails are extremely corroded (See Photo S-1). It appears that the corrosion has initiated scaling of the steel material. Visual observation does not allow a determination of the full extent of the corrosion because the rails are set in sleeves within the concrete. The immediate concern is that the corrosion has advanced to an extent where loss of the section has occurred. Section loss results in reduction of the structural capacity of the vertical posts. This is considered a safety concern and should be addressed immediately. It is recommended that the steel rails be removed and replaced. Upon removal of the rails, inspection of the surrounding concrete will be required to determine if additional remedial work is required prior to setting new rails.

The tent structure above the party deck is attached to the vertical posts of the guardrail, so the tent structure will need to be removed to replace the vertical posts of the guardrail. The wood deck also obstructs access to the base of the vertical posts and areas of decking may need to be removed to replace the posts.

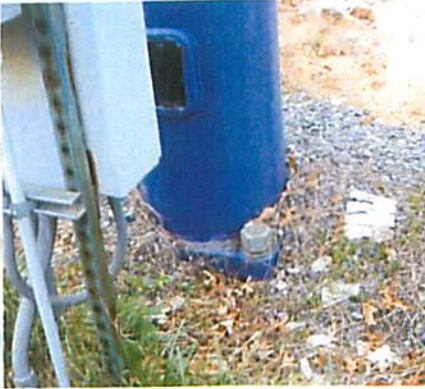
Photo S-2

- d. The bases of several masts are covered by earth (See Photo S-2). If the steel surfaces are buried directly below grade, they are more susceptible to corrosion due to prolonged moisture exposure. Localized regrading should be undertaken such that the base plates and anchor rods are exposed and water does not collect at the base.

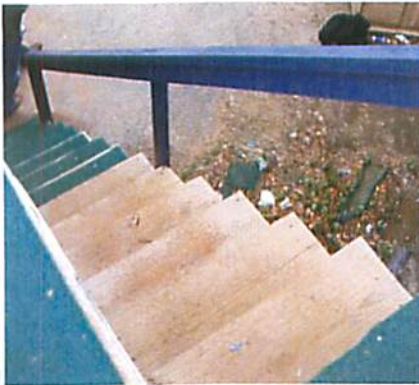
Photo S-3

- 4) There is a wooden stair that allows access to the roof of the bullpen behind the right field wall. This stair exhibits movement as a single person walks the stair and overall is in poor condition (See Photos S-3, S-4). The handrail is also insufficiently attached to the stair. This stair is considered unsafe and should be removed and replaced with a properly engineered stair.

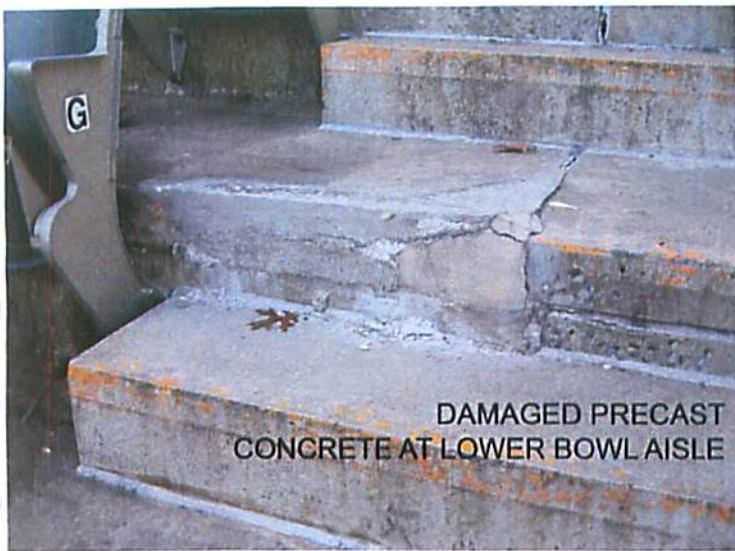
- 1) **Spalled Concrete:** Structural remediation is required at locations where concrete has cracked and spalled at guardrail post locations and at cast-in-place concrete treads on precast tiers (see Photo S-5 to S-8). These conditions occur at various locations throughout the lower and upper seating bowls. The cracked and spalled concrete present safety and liability concerns due to potential of falling loose concrete, potential tripping hazards and compromised integrity of the rail anchorage.

DAMAGED PRECAST
CONCRETE AT LOWER BOWL AISLE

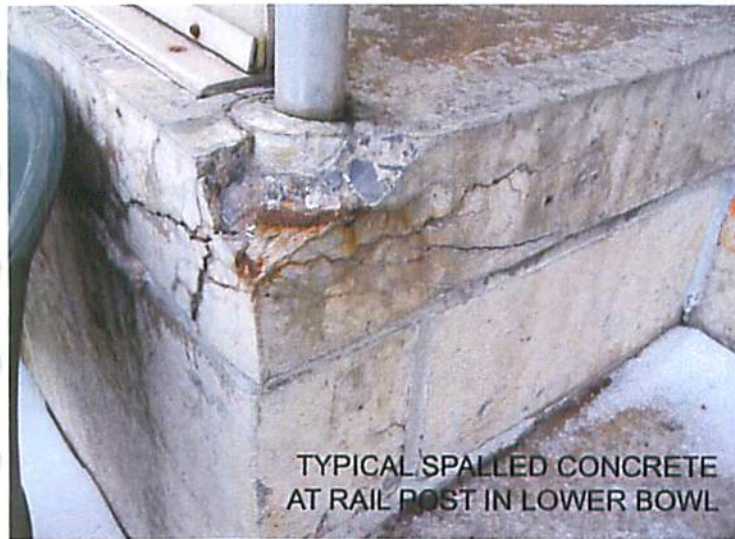
Photo S-7

TYPICAL SPALLED CONCRETE
AT RAIL POST IN LOWER BOWL

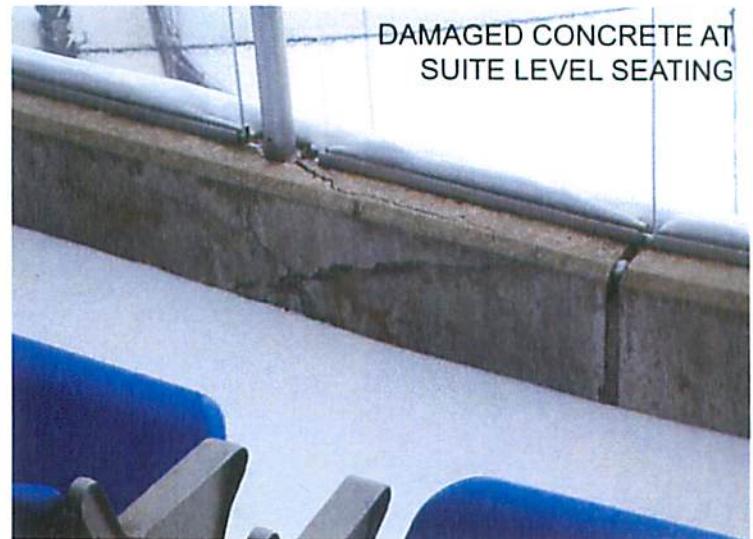
Photo S-8

DAMAGED CONCRETE AT
SUITE LEVEL SEATING

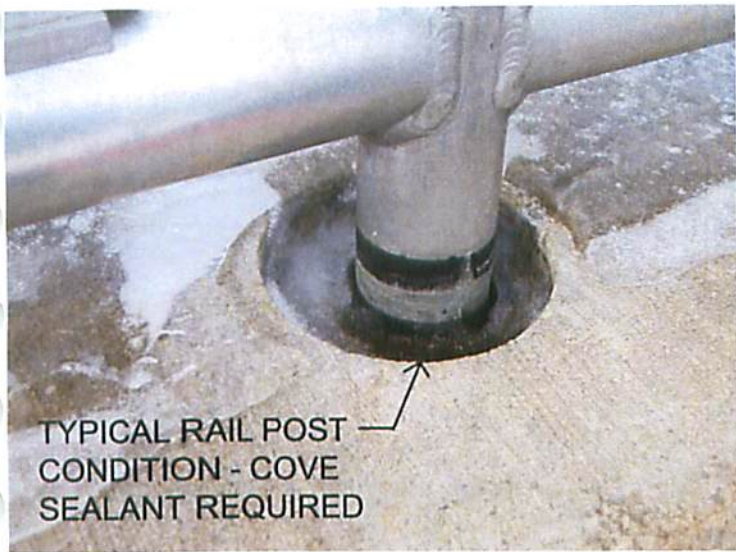
Photo S-9

The typical rail to concrete connection is a vertical post set in a cored hole in the concrete and packed with a cementitious material. In many cases the packing material is recessed relative to the surrounding concrete creating an area for water to collect (see Photos S-9 to S-12). Water penetrates the concrete and expands during freezing cycles resulting in concrete spalls between the vertical post and concrete edge. Many of these conditions appear to have been previously patched and are cracking and spalling once again. Repair of these conditions requires the removal of the loose material down to sound substrate along with concrete replacement through development of appropriate repair details. Proper detailing and installation of the cementitious packing material and cove sealant around the vertical post base to create positive drainage away from the post will be critical to maintaining the future integrity of the repair. Consideration should be given to surface mounting vertical rail posts to eliminate the cored hole condition that is currently creating a source of water penetration.

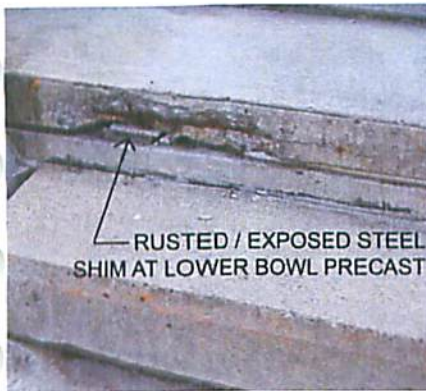
Photo S-13

- 2) **Rusted Reinforcing Steel:** Rusting of concrete reinforcement is evident at various locations throughout the upper and lower seating bowls where concrete spalls have occurred (see Photo S-13). At these conditions, the exposed reinforcing bars should be evaluated to determine if the corrosion has advanced such that loss of section has occurred. Where loss of section has occurred, remedial details will need to be developed to replace the damaged reinforcement. Where corrosion is limited to surface rusting, the exposed reinforcing bars should be cleaned and coated with a high quality corrosion protection product. The surrounding concrete should be cleaned and coated with a bonding agent and patched with an appropriate repair mortar. Reinforcing bars that are left untreated will continue the corrosion process resulting in continued expansion of the reinforcing material, loss of section and spalling of adjacent concrete elements.

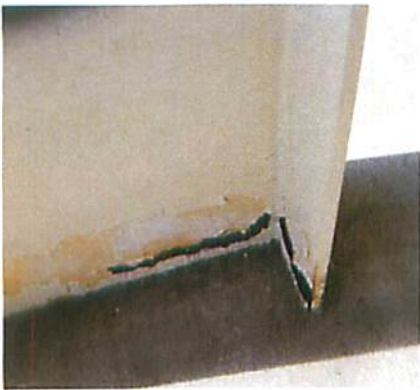
Photo S-18

- 1) **Corroded Steel:** Steel members throughout the stadium exhibit various levels of corrosion. In the majority of the conditions the corrosion is limited to local surface rusting. These conditions occur at the base of columns in concourse areas (see Photo S-18) and at exposed steel supporting the Suite Level. The rusting associated with these members appears to be the result of sustained exposure to water through localized pooling or leaking of joints in precast above (see Photo S-17). At the column base conditions, removal of the concrete surrounding the steel will be required to allow full cleaning of the steel prior to coating with a high quality corrosion protective paint system. The area surrounding the base of the column should be filled with a repair mortar and built up to

provide a wash that creates positive drainage away from the surface of the column. A concrete plinth could also be provided and designed as an architectural feature. The joint between the repair mortar and the steel columns should be filled with a high quality flexible sealant. At the exposed steel supporting the Suite Level, local surface rusting should be cleaned to bare steel and be coated with a high quality corrosion protective paint system. Further investigation is warranted to determine the source of the water at this location and develop appropriate repairs to eliminate the corrosion source.

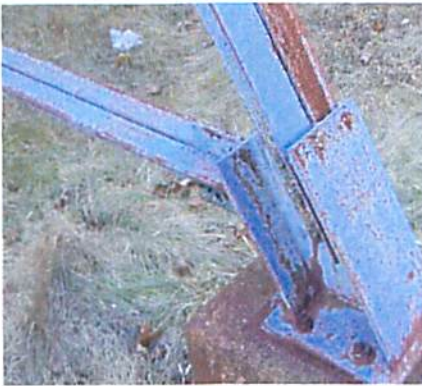
Photo S-19

Surface rusting is prevalent along the length of some of the steel members at the outfield structures supporting the scoreboards and various signs (see Photo S-19). The rusting associated with these members appears to be the result of deteriorated paint surfaces and direct exposure to the elements. These members should be cleaned to bare steel and coated with a high quality corrosion protective paint system.

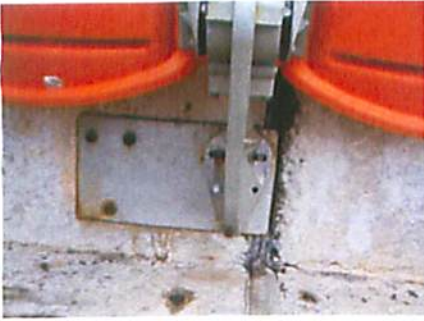
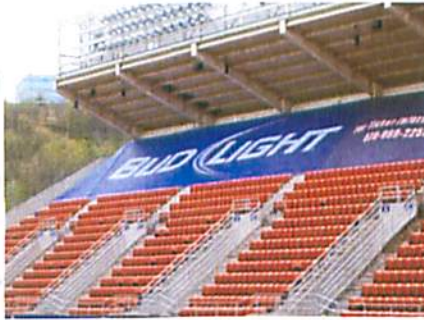
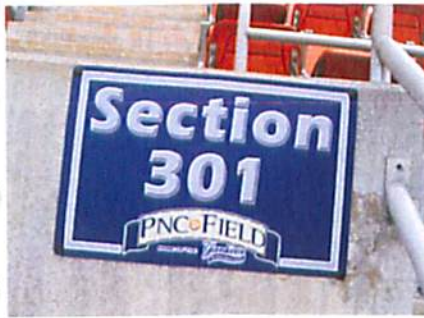
Photo A-1

- 3) **Loose Material in Bowl / Concourse:** Areas containing tripping hazards were noted in the lower bowl, i.e., loose metal in a right field bowl aisle and loose caulking material at the right field expansion joint (See Photos A-2, A-3). Additionally, in the upper concourse near right field, the existing deck coating is delaminating and poses a tripping hazard. These conditions should be immediately remedied.

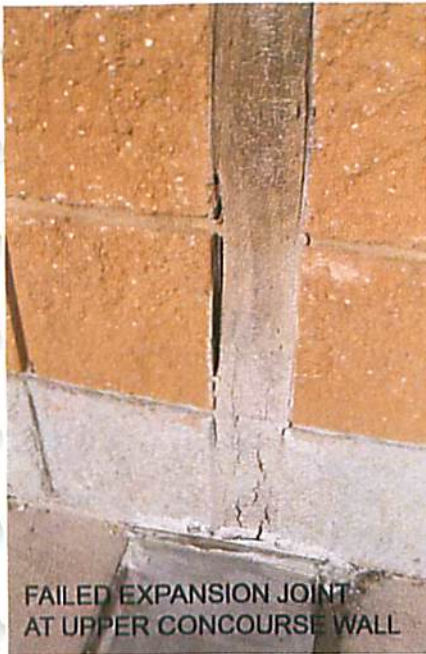
- 2) **Expansion Joints:** The building consists of two expansion joints which dissect the structure at all levels, one at column line 107 and one at column line 307. Just as with the sealant joints, the expansion joints appear to have failed with signs of deteriorated sealant at the wall and floor slab locations, resulting in weather exposure and moisture infiltration (See Photos A8 - A9). We recommend that new expansion joint systems be installed, with special attention to providing watertight transitions.

Our review of the expansion joints was limited to just those portions that we could readily see from the adjacent walking surfaces. For the seating bowl expansion joints, we could only observe the topside condition. We were not able to review the underside of the joint which would have required a special lift. For this reason, and based on the information above, we recommend (again) that a specialty subcontractor be hired to examine all expansion joints, especially those overhead.

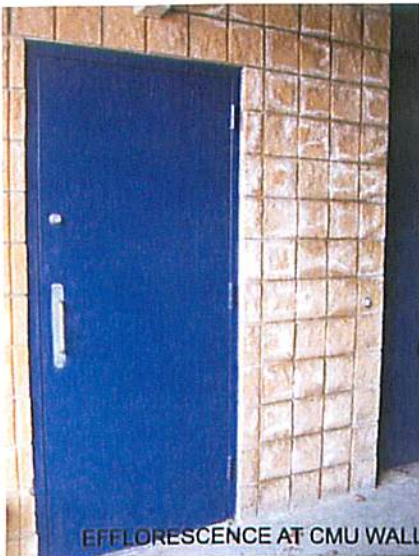
A16

The standing water and moisture has lead to efflorescence in the base course of the masonry walls, corrosion at the steel column bases and severe corrosion at the base of certain metal doors and frames, on both levels, which were mentioned above (See Photo A16). While adding a concrete topping and waterproofing system could mitigate the negative effects of standing water, we recommend relocating and/or adding area drains in the upper and lower concourses. The quantity and locations of the area drains required to address this issue, and the recommended slope configuration of the concourses, would be dependent on a more complete survey of the concourse slopes.

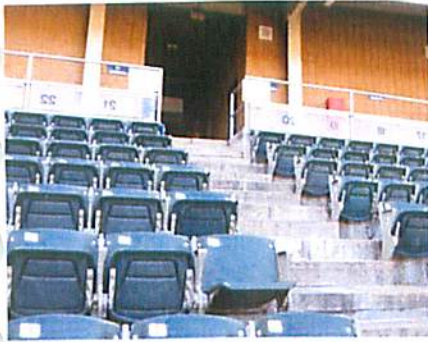
A17

3) **Bowl Railings:** It was generally observed that some of the railings in the seating bowl do not meet current building code standards. As one example, there are no center-aisle railings in the upper bowl (See Photo A17). As another example, the front guardrail at the upper bowl does not comply with the 4" maximum gap criteria required (See Photo A18). The current railings may be permitted to be left as is, as long as remedial work in the seating bowl doesn't trigger the need to upgrade the railings to current codes; however, from an Owner liability standpoint, consideration should be given to modifying the railings to meet the current adopted codes. At that time, we would recommend a thorough assessment of all bowl railings be performed to assure code compliance.

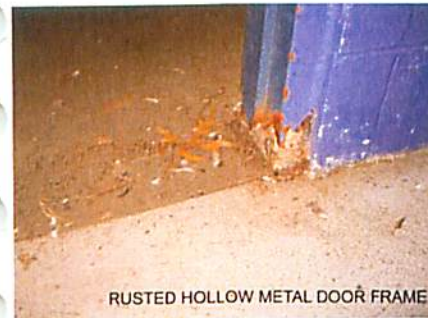
A19

4) **Hollow Metal Doors & Frames:** Several hollow metal doors and frames on the Main concourse in the vomitories and along the upper concourse are exhibiting varying degrees of rust and deterioration at the bottom due to prolonged exposure to water (See Photo A19). The exposure to water is due to an insufficient number of concourse floor drains and/or lack of proper slope to the drains, and away from door openings. We recommend the corroded frames be repaired or replaced. It is possible to cut off the bottom of the hollow metal frames and a new piece welded on. Whether a new piece is added, or all new frames are installed, we recommend the frames be grouted solid to help prevent future deterioration from moisture. All corroded doors should be replaced and new thresholds added to prevent water infiltration under the door. Ideally, a solution should be sought to provide positive drainage away from the doors and vomitories.

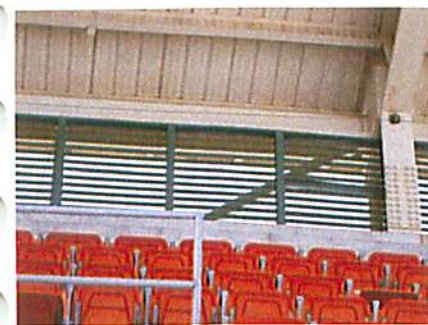
A20

5) **Upper Bowl Louvers:** There are aluminum louver assemblies which provide a screen behind the last row of seats in the upper bowl. Reportedly, the anchors of some louvers have failed during high winds (See Photo A20). Some blades were missing and/or were observed to have been dislodged from the frame. The engineering staff has repaired the loose or failed anchorages, but we would recommend further evaluation of the louver anchoring system to assure the assembly is secure and does not pose a life safety threat.

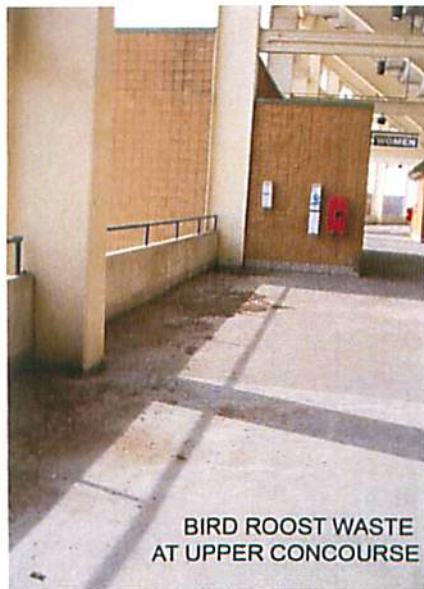
A23

7) **Bird Roost:** Extensive bird roost waste was observed throughout the stadium. The most severe locations were observed on the outer structural ring above the upper concourse (See Photo A23); however, there was waste observed at many locations throughout the stadium. At best, bird waste will permanently damage paint and other material finishes. At worst, bird waste can pose a health hazard to the stadium occupants. Reportedly, the maintenance staff regularly has to shovel the bird waste from the concourse floor surfaces in the more severe locations.

Bird roosting is common for outdoor stadia because of the plethora of available roosting ledges and the abundant presence of food. There are a variety of bird deterrent systems available on the market; however, the success of such systems varies. While we have seen some success in other stadiums with the installation of netting to prohibit access to the roosting areas, we recommend a specialty subcontractor be consulted to offer remedies to this particular issue. For the roosting areas above or near food service areas of the stadium, consideration should be given to making this an immediate priority due to the potential for health risks.

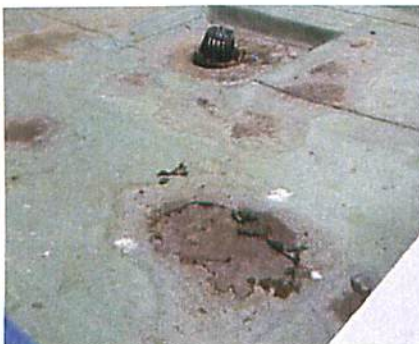
A26

3) **Roof Construction:** Existing roof construction consists of metal standing seam at the outer peripheral areas and a metal panel system at the upper deck which are original. Later additions and infill construction, at the stair towers and home team locker room / clubhouse consist of adhered singly ply membrane. Portions of these roofs, where visible from the concourse, appear to be coated to match the standing seam. It was observed at a few stair locations that the coating is peeling off and debonding from the original black EPDM

roof (See Photo A26). Even though there does not appear to be any evidence of membrane deterioration, the roof areas should be inspected periodically, as part of the maintenance program.

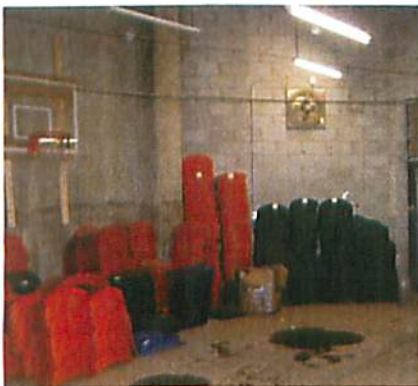
E1

2) **Storage in Electrical Rooms:** It was observed that the Main Electrical Room and Emergency Generator Rooms are being used for storage of materials. Further, a basketball hoop is installed on the wall near the emergency generator (See Photo E1).

These conditions are in direct violation of the National Electrical Code and pose a serious fire and safety hazard. All stored material should be removed immediately and the basketball hoop taken down.

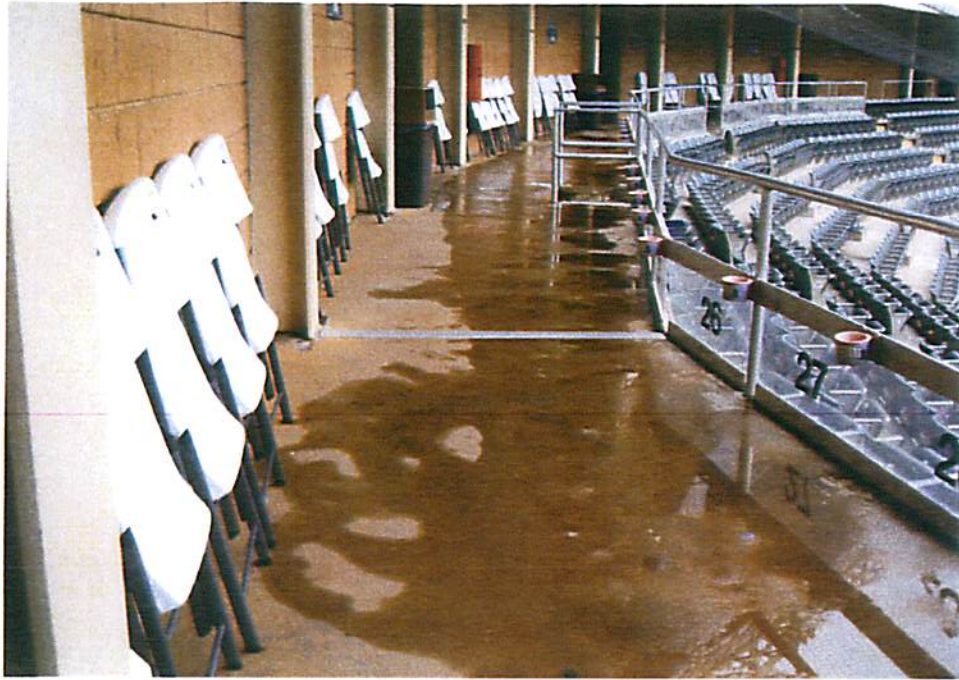
FAILED JOINT SEALANT /
SPALLED CONCRETE NOSING
AT LOWER BOWL AISLE
